#### City of Richmond CSO Control Program

#### Richmond CSO Long-Term Control Plan

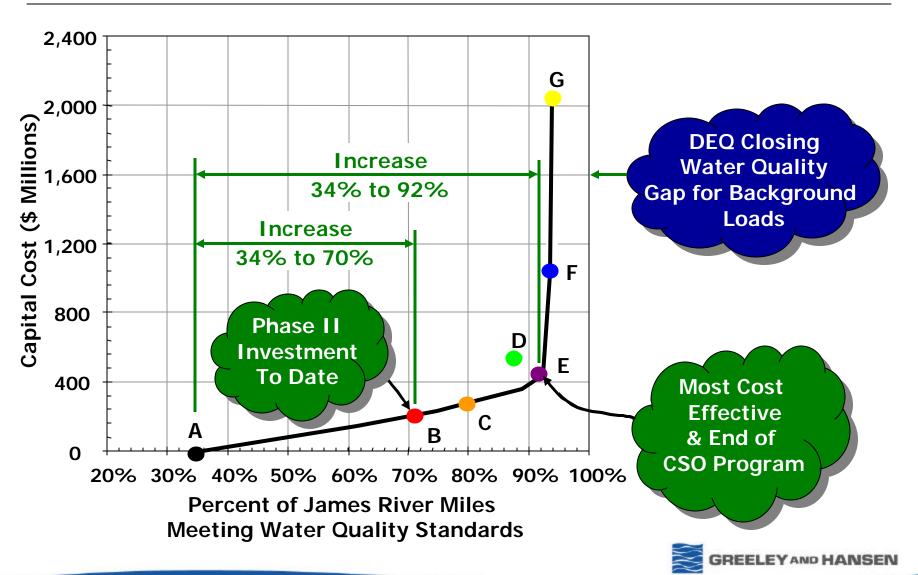
#### LTCP Re-Evaluation Results

Percent of James River Miles Meeting Fecal Coliform WQS

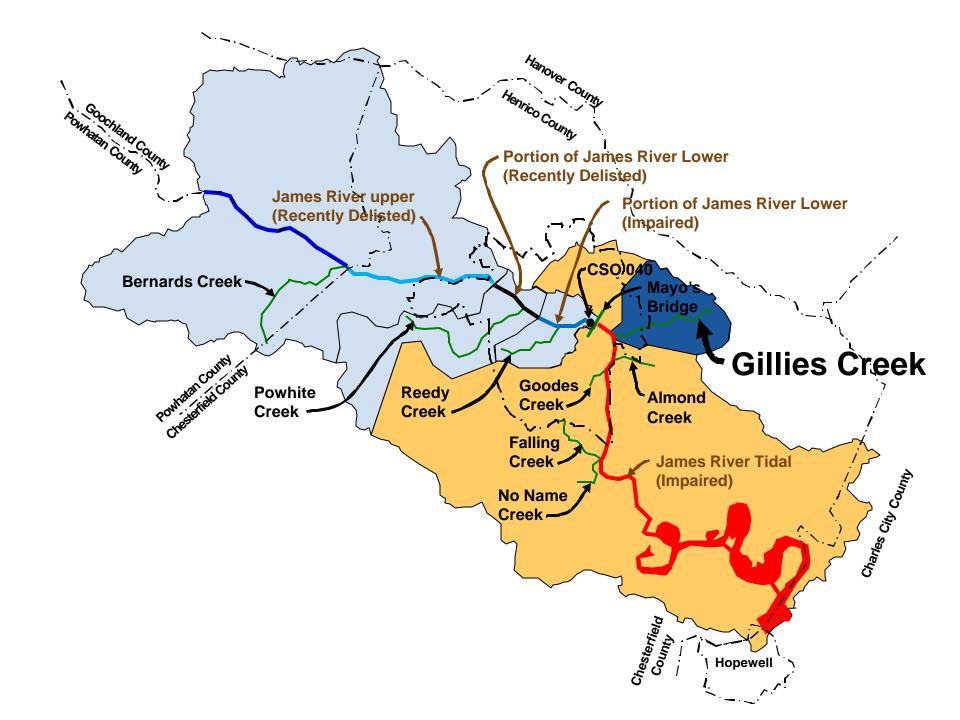
#### Water Quality Standards Coordination Process James River Bacteria TMDL

- Riverine Segment

- Tidal Segment

Alternative "E" will meet 126 GM WQS

Additional
Evaluation Needed
During IP

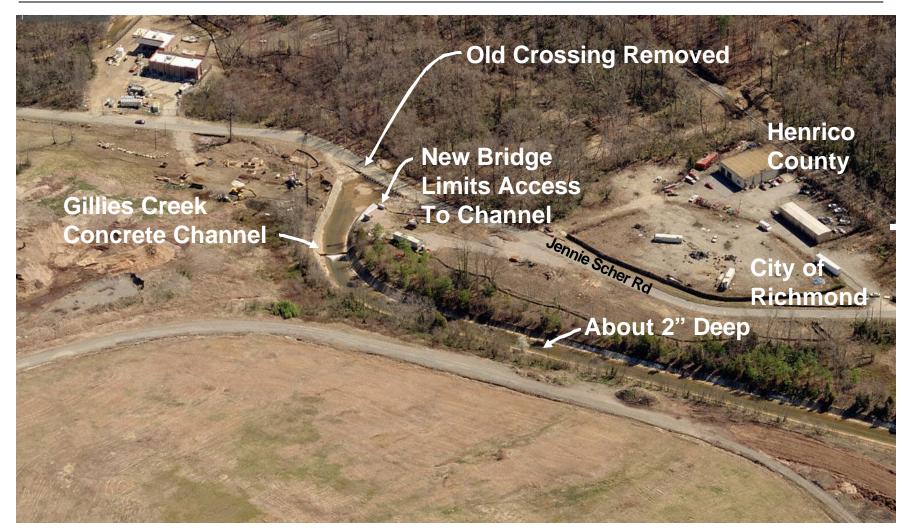
# Picture 1 Gillies Creek at City Border

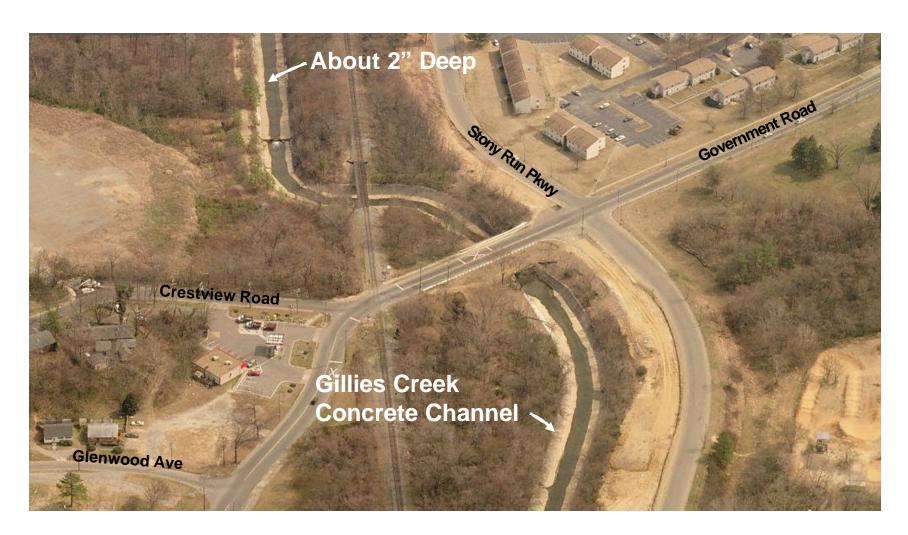
## Picture 2 Gillies Creek at Government Road

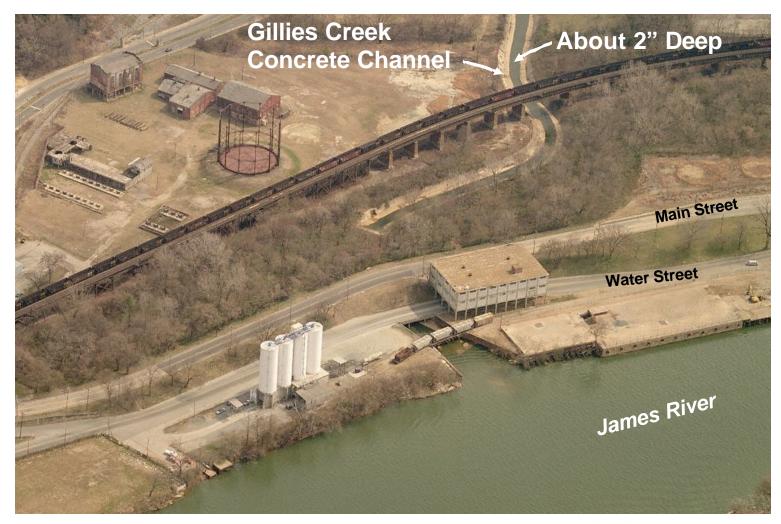
## Picture 3 Gillies Creek at James River

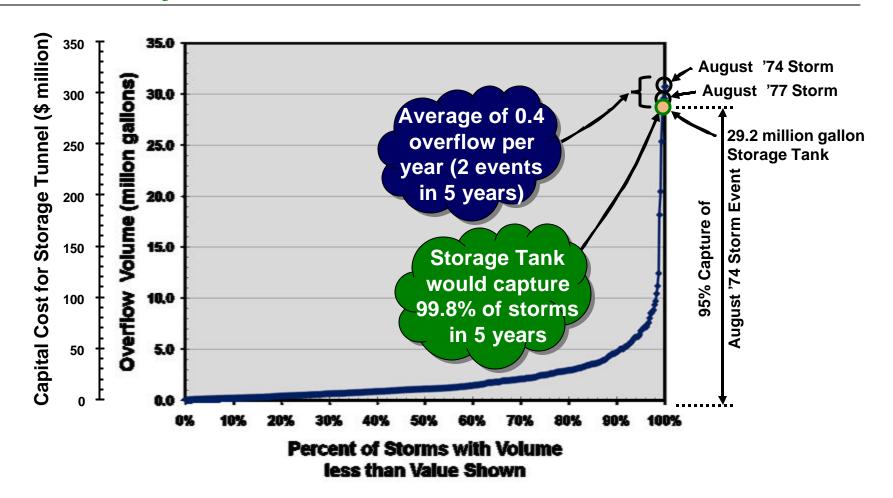
## **Gillies Creek Primary Contact: Bacteria Reduction at 95%**

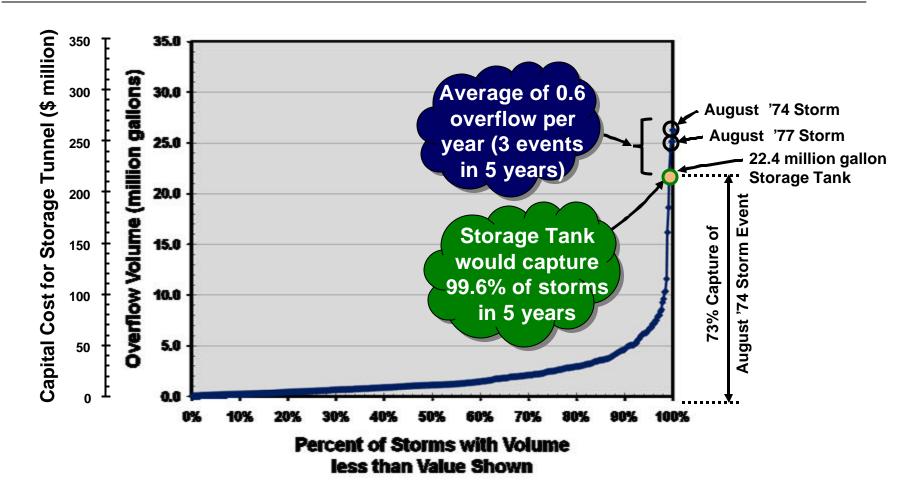
### Gillies Creek Secondary Contact: Bacteria Reduction at 73%

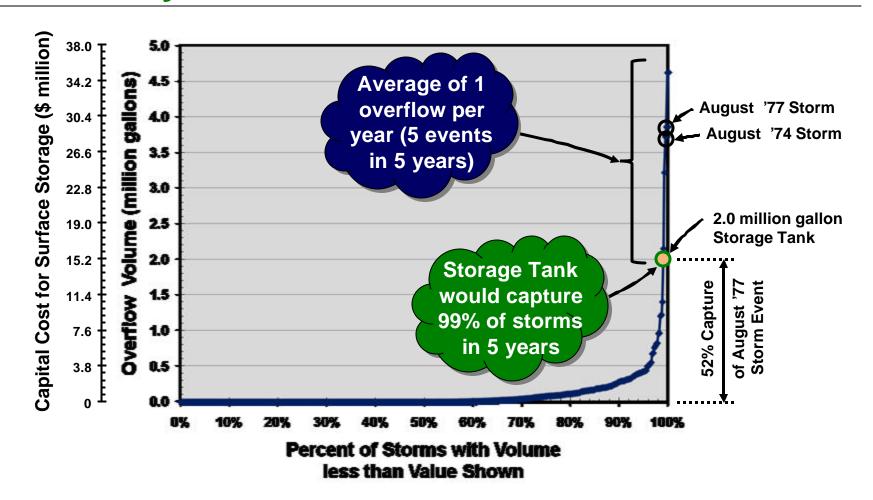
## **Almond Creek Primary Contact: Bacteria Reduction at 52%**

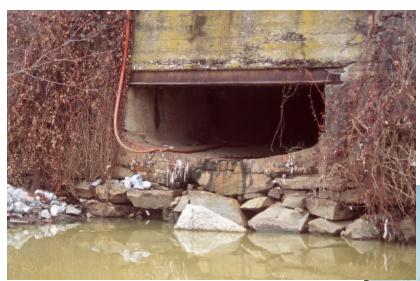
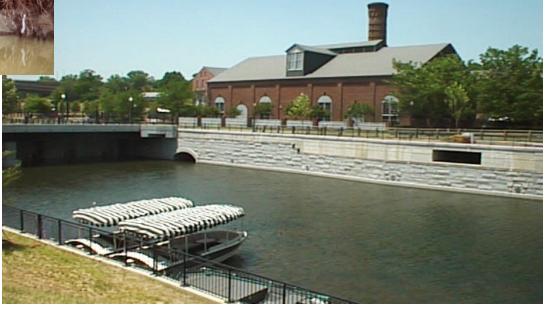
# Gambles Hill CSO Outfall Before and After CSO Control (1996)

**Before (1996)**

**After (1998)**
